East River Esplanade, 90th to 125th Streets

2/24/2021 Update 2

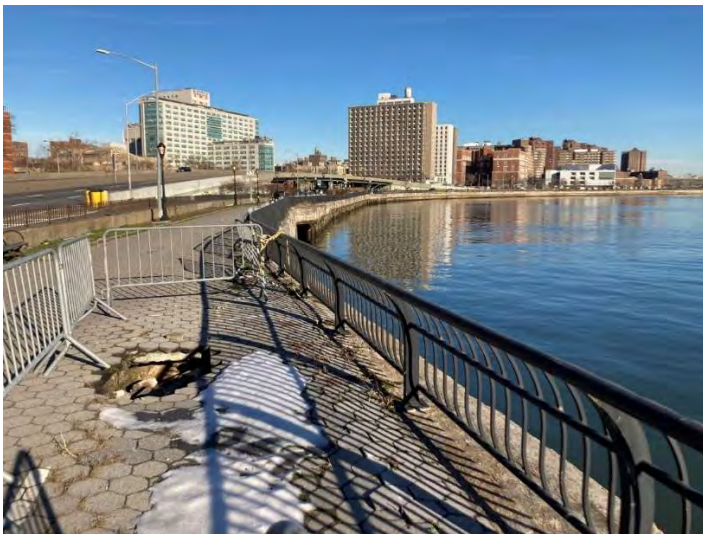
Photo 1 : Looking north from 93rd street, typical sink hole, one of many. See "A" on Keymap

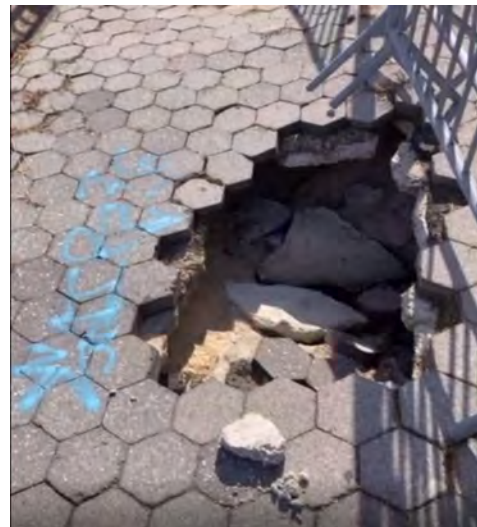
Close up of the same sink hole. See "A" on the keymap, page 3.

Above: Hexagonal pavers and concrete topping have collapsed into a **cavity formed by tidal action and water seeping underneath the structure**. This happens frequently along the esplanade. Temporary barriers are installed for safety here.

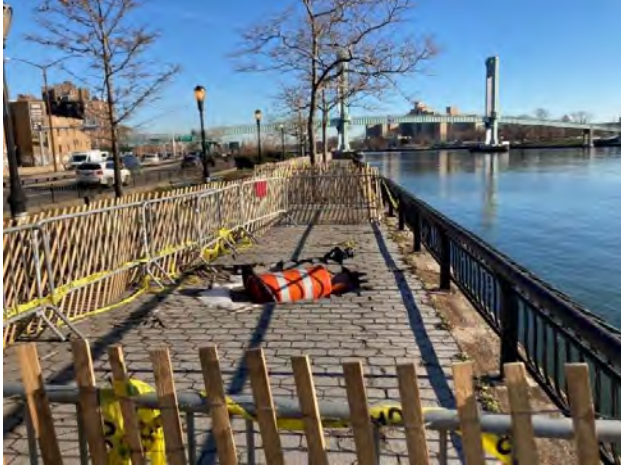
Photo 2 Looking north from 98th St. Another sinkhole from tidal action. The FDR drive can be seen to left, adjacent to eroding structure.

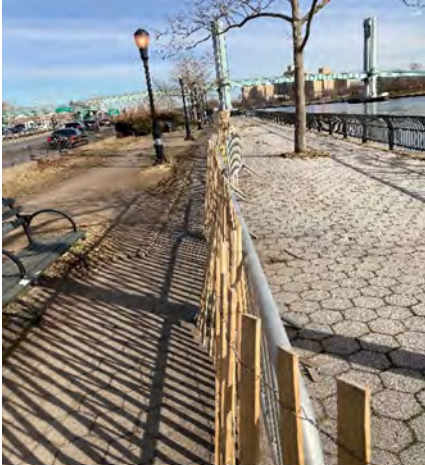
Fencing around multiple sinkholes often leaves only a narrow strip of bare earth between fencing and the FDR

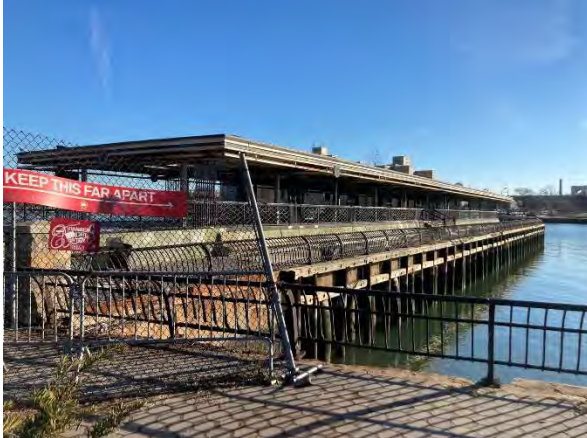
Photo 4: Pier at 107th Street: See "C" on Keymap
Potentially at major destination, it has deteriorated and been deemed unsafe and closed.

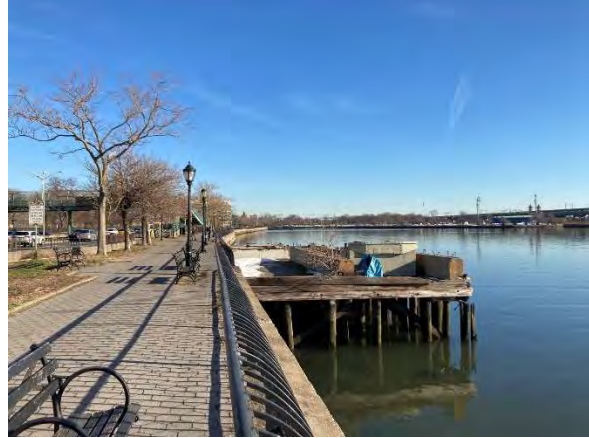
Photo 5: The smaller pier at 110th street is deteriorated and closed to public. It could be destination for fishing or sitting, away from FDR.

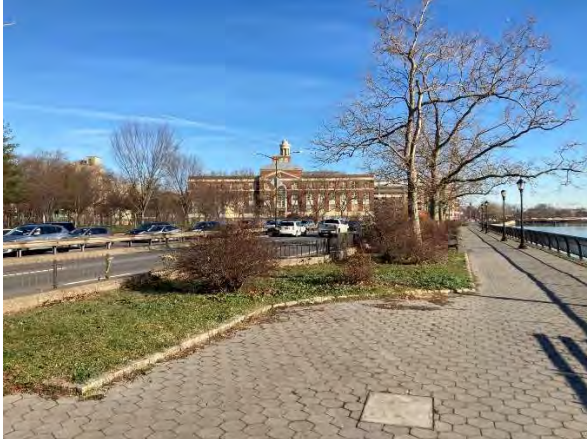
Photo 6: The remaining areas have minimal planting to obscure noises of nearby cars.

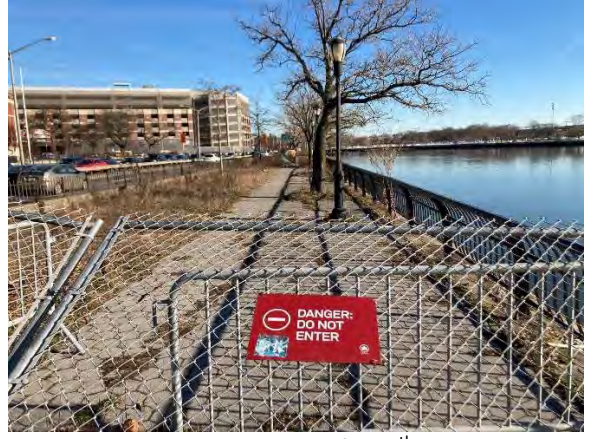
Photo 7: Esplanade north of 114th street has all been closed for safety concerns from structure. See "D" on Keymap, page .

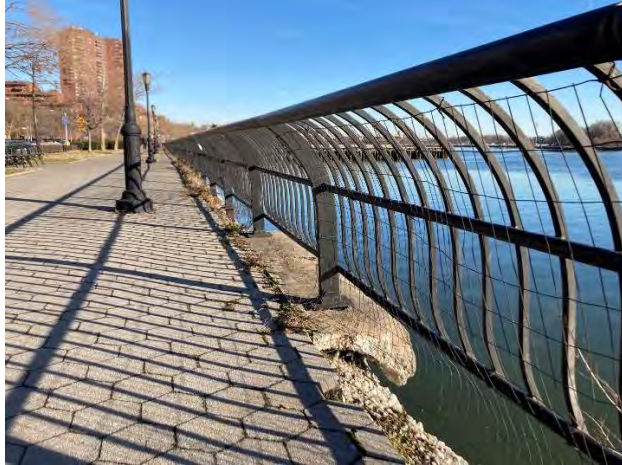
Photo 3: Typical Railing near 105th Street looking north. Concrete is deteriorating under the rails. Balusters in background are not attached to anything as the concrete is missing

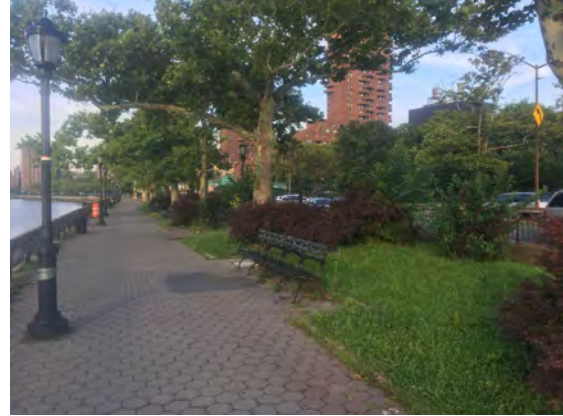
For comparison and to show potential: Around 112th street across from Thomas Jefferson Park, this brief section has better planting and not yet any collapsing sink holes. In addition to repairs needed elsewhere, preventative structural work will be needed to preserve the remaining places like this.

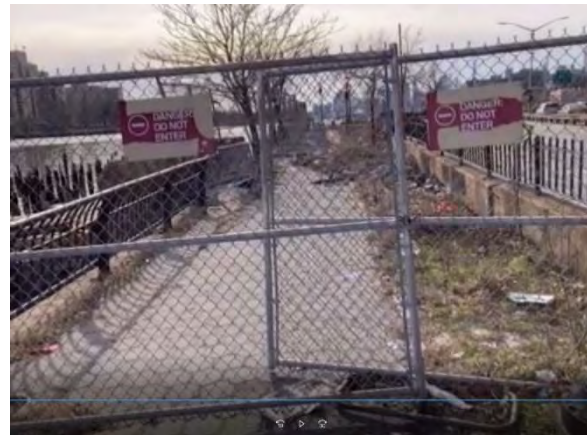
Above: Fencing at 117th street, looking south.
